DEPARTMENT OF TRANSPORTATION

Quality Assurance and Source Inspection

Contract #: 04-0120F4Cty: SF/ALA Rte: 80 PM: 13.2/13.9File #: 1.28**WELDING INSPECTION REPORT****Resident Engineer:** Casey, William**Address:** 333 Burma Road**City:** Oakland, CA 94607**Report No:** WIR-026687**Date Inspected:** 11-Nov-2011**Project Name:** SAS Superstructure**OSM Arrival Time:** 700**Prime Contractor:** American Bridge/Fluor Enterprises, a JV**OSM Departure Time:** 1530**Contractor:** American Bridge/Fluor Enterprises, a JV**Location:** Jobsite**CWI Name:** As noted below**CWI Present:** Yes No**Inspected CWI report:** Yes No N/A**Rod Oven in Use:** Yes No N/A**Electrode to specification:** Yes No N/A**Weld Procedures Followed:** Yes No N/A**Qualified Welders:** Yes No N/A**Verified Joint Fit-up:** Yes No N/A**Approved Drawings:** Yes No N/A**Approved WPS:** Yes No N/A**Delayed / Cancelled:** Yes No N/A**Bridge No:** 34-0006**Component:** SAS OBG**Summary of Items Observed:**

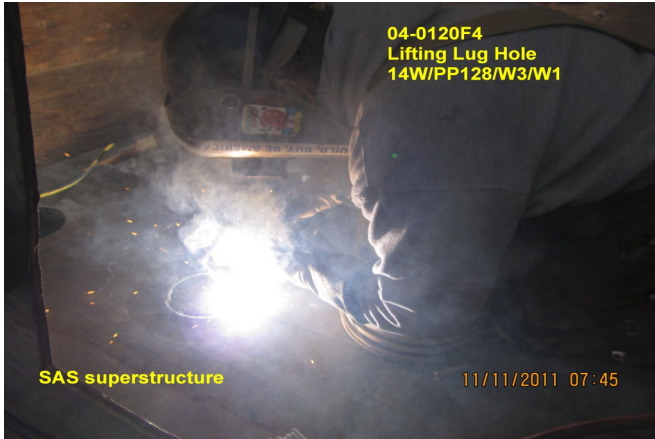
This QA Inspector made random observations of ABF welder Jorge Lopez (ID 6149) perform the Shielded Metal Arc Welding process (SMAW) in the 1G flat position on Lifting Lug Hole (LLH) 14W PP128 W4-W4. This QA Inspector observed QC Inspector Sal Merino measure the pre-heat temperature to verify a minimum of 10°C was achieved. This QA Inspector also observed the QC Inspector monitoring the welding and verifying that the parameters were in compliance pertaining to ABF-WPS-D15-1050A-CU. The parameters were recorded as (Amperes=195) utilizing a 4.0 mm E7018-H4R electrode. During in process welding, this QA Inspector noted that the QC Inspector measured the inter-pass temperatures to maintain a heat range below 230°C. At approximately 1000 hours, ABF Welding Supervisor Eric Sparks canceled welding operations at this location due to inclement weather.
